ASSESSMENT OF THE USE OF SEAT BELTS IN BUSES BASED ON RECENT ROAD TRAFFIC ACCIDENTS IN SPAIN

Ignasi Ferrer

IDIADA AUTOMOTIVE TECHNOLOGY SA

Paper Number 222

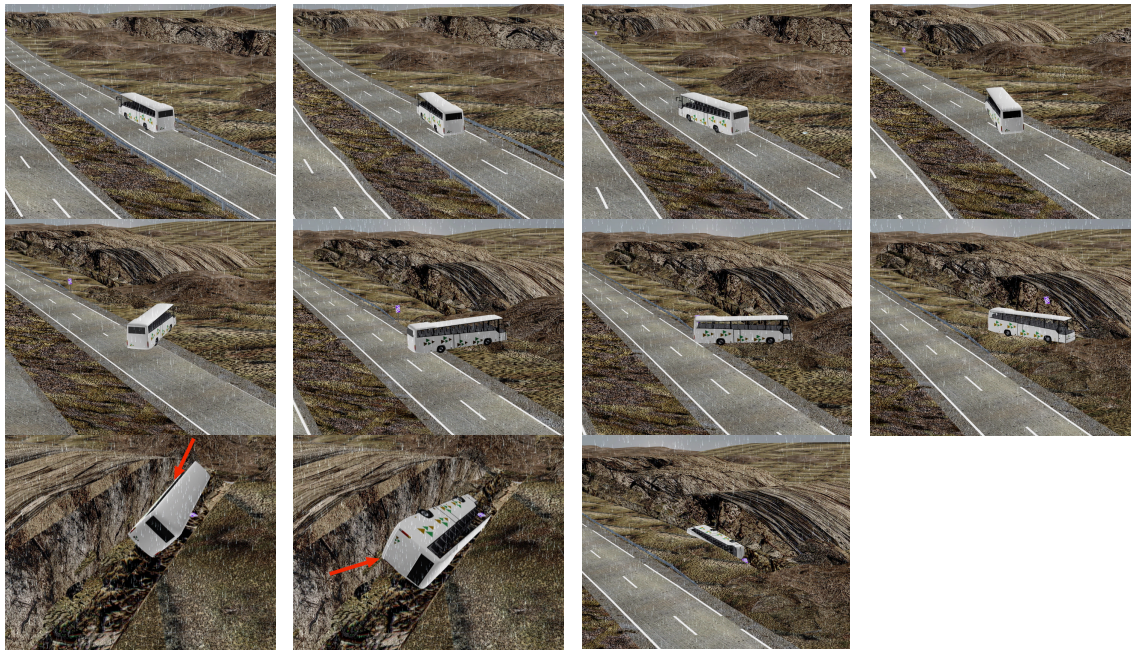
Figure 2. Sequence of the accident.

The bus consists of a chassis SCANIA K113 CLB and a body CAETANO Delta. There are 57 seating positions on it, including the driver seat and the guide seat at the front left side of the bus. The kerb weight of the bus is 13300 kg and it has two axles. The front axle is single and the rear one is double. Figure 1 shows a photograph and a drawing of the vehicle. The sequence of the accident is shown in Figure 2. The bus was driving at noon on the motorway at a speed of 106 km/h. It was raining. At a certain moment, the skidding of the rear axle started. From that moment on, the bus reeled from side to side, eventually spinning around 180 degrees, completing this turn outside the road. At the place where the bus left the road, there was no retention barrier. The bus left the road and rolled over. Right at that place where the bus fell, there was a small watercourse, with a depth of water of one meter and a half at that time.

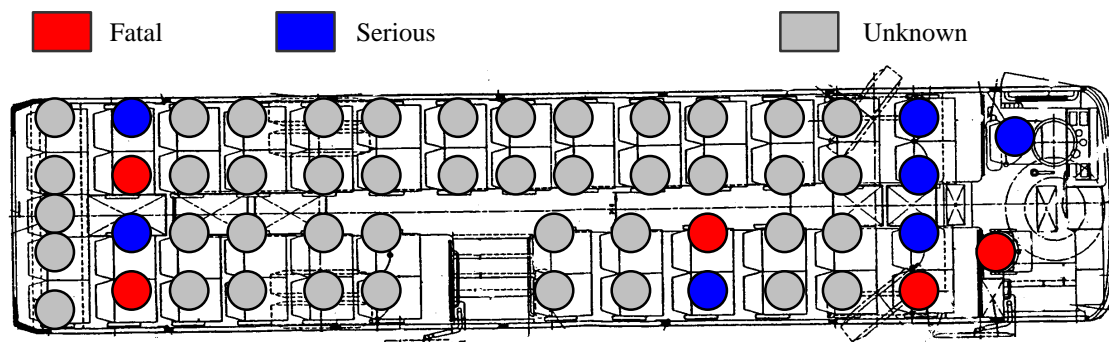
Figure 3. Severity of occupant injuries.

The number of occupants was 52, including the driver and the guide. All of them were ejected from

their seats and most of them were thrown out of the bus, fell in the watercourse and died.

The occupants whose position before the accident is known are represented in different colours. The persons who occupied those positions painted in red, died. The occupants of the seating positions coloured in blue were considered seriously injured by the police.

This case is a typical situation of occupant ejection in a rollover accident. The vehicle kinematics during the rollover has not been precisely determined. The position of most of the passengers before and after the accident is unknown. Most passengers drowned in the watercourse. An occupant simulation was not carried out in this case. It had been difficult to fix the boundary conditions and validate any possible results.

The first case is a bus rollover accident without any collision against other vehicles. The ejection of the occupants is the fact that initiates the production of fatal injuries due to impacts. In this case, most of the passengers were drowned in a watercourse. It is clear that a three-point seat belt would avoid such ejection and reduce the risk of injuries.

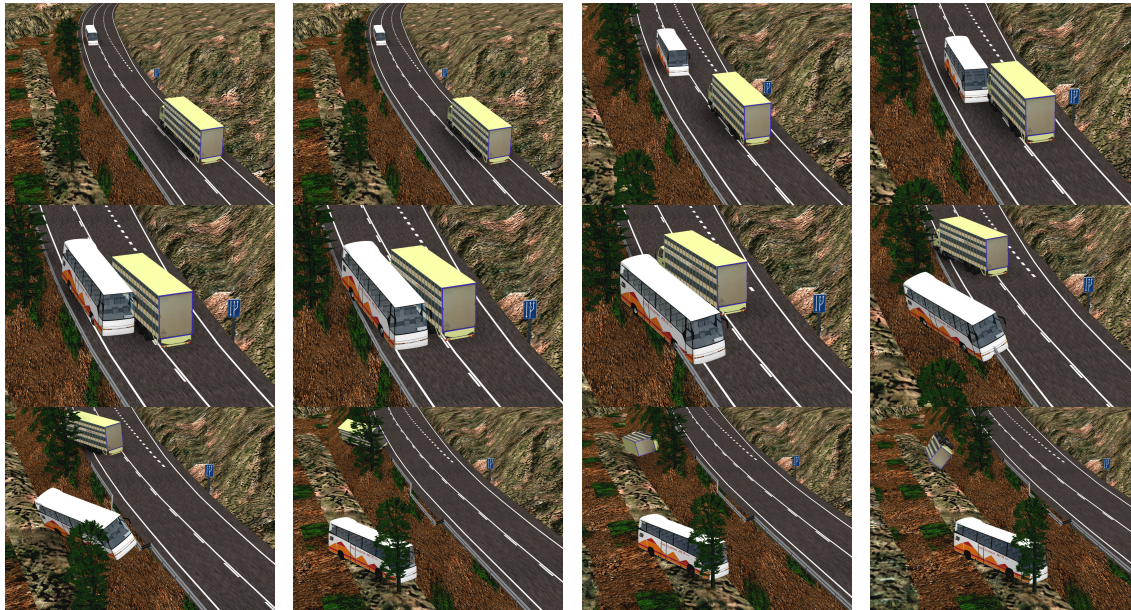
Figure 6. Sequence of the accident.

The sequence of the accident is shown in Figure 6. The truck was driving towards a curve to the right on a national road at 81 km/h. The truck invaded the opposite lane and collided with the bus, driving in its lane at 99 km/h. During the collision the left side of the coach was extremely deformed. After the impact, the truck followed a straight trajectory through the opposite lane, it crossed the barrier and left the road. The bus left the road on its right side moving laterally.

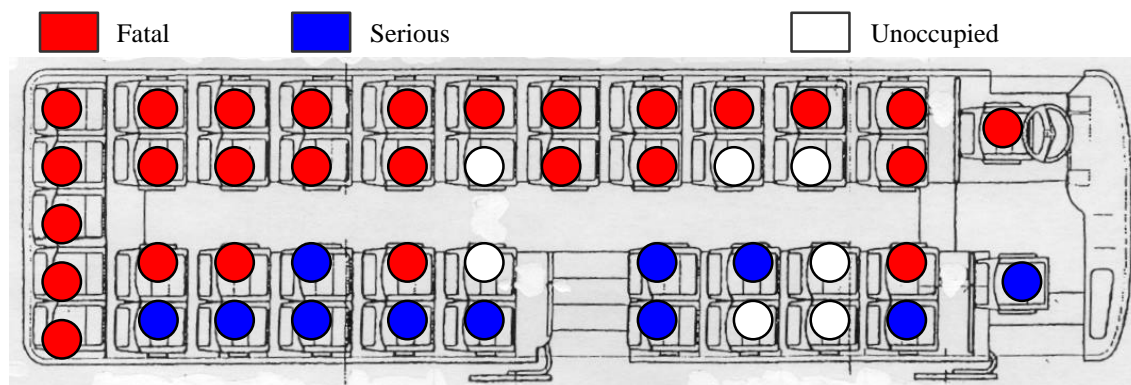
Figure 7. Severity of occupant injuries.

The seating positions in the coach are shown in Figure 7. The persons who occupied those positions painted in red, died. The occupants of the seating positions coloured in blue were seriously injured, according to the subjective evaluation of the police. Six seats were unoccupied.

All passengers sitting at the left side of the coach died. The occupants would not benefit from wearing a seat belt. The photographs of the vehicle after the

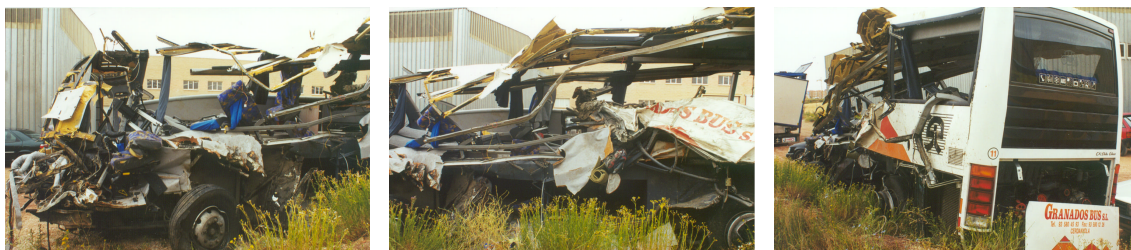
Figure 8. Photographs of the left side of the vehicle.

accident in Figure 8 show the deformations at this area.

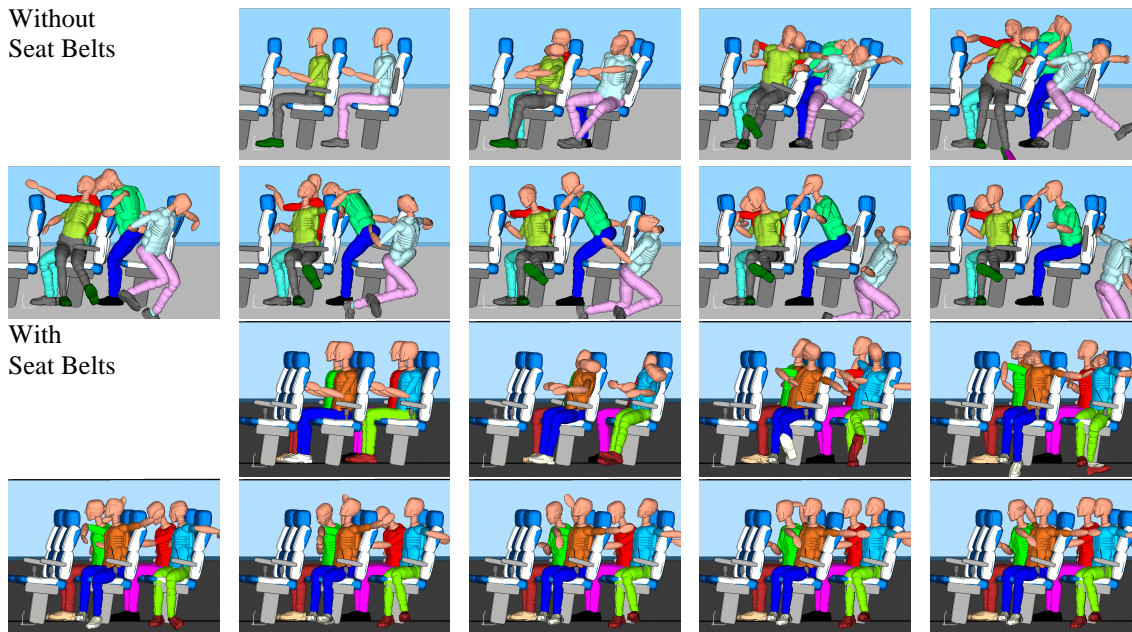
Figure 9. MADYMO® animations for the right-side area.

At the right side area, a first simulation on the selected seating positions was made to compare with the real accident. In this case, the occupants were unrestrained. A second simulation was made with a three-point safety belt on each seating position. The properties of that seat belt were taken from an existing model of bus seat. The simulation results for this area are shown as animations in Figure 9.

The occupant simulation without seatbelt considers that the armrest is down in the first row. The ejection is avoided but the armrest produces serious abdominal injuries. At the second row the armrest is folded up and the occupant is ejected to the left. This is the case producing fatal injuries to the occupants sitting on the central positions at the right side of the coach. With three-point seat belts, there is no ejection and the position of the armrests has almost no influence on the results.

The second case is a frontal collision with offset of a bus against a truck moving in the opposite direction. The direction of impulse is almost lateral. Passengers seating in those positions where a direct intrusion occurred could not have been saved by using a seat belt. But a three-point seat belt could have reduced the risk of injuries to all passengers seating at the right side of the vehicle. These were 18 people, 7 of them died and 11 were seriously injured. Again the ejection is the primary cause of serious and fatal injuries.

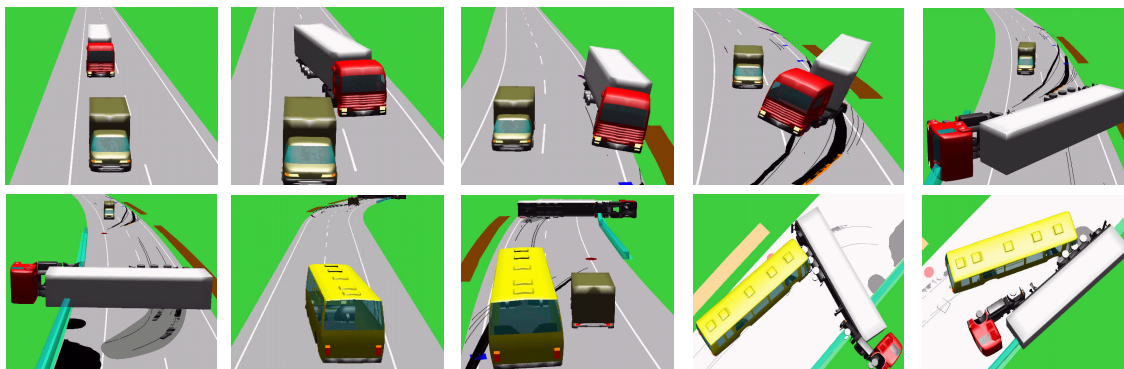
Figure 12. Sequence of accident events from PC-CRASH® animation.

The sequence of events is shown in Figure 12. The articulated lorry was driving at 96 km/h on the motorway when it started an overtaking manoeuvre. While changing to the left lane it went out of the asphalt. The driver tried to correct its way but the lorry rolled over on its left side while the driver was jumping out of the tractor cabin. The overtaken truck stopped from 70 km/h on the right lane and turned the

warning lights on. The articulated lorry was lying on its left side across both lanes of the motorway. The distance between the two trucks was 50 meters when stopped. Some seconds after, the single-decker coach was driving towards that point at 105 km/h. The driver saw the truck stopped on the right lane but he did not reduce the speed of the bus. Instead, he decided to overtake that truck at cruising speed. While driving on the left lane, he was making signals with the full-beam headlights. He noticed the obstacle at a distance between 40 and 50 m to the overturned lorry and braked. The bus crashed against the underbody structure of the semitrailer. The impact speed was 70 km/h.

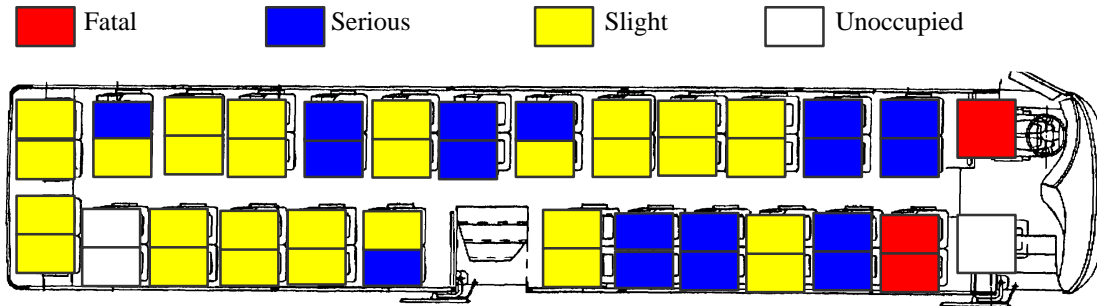
Figure 13. Severity of occupant injuries according to the police report.

The seating positions in the coach are shown in Figure 13. The persons who occupied those positions painted in red, died. The occupants of the seating

positions coloured in blue were seriously injured, according to the subjective evaluation of the police. The passengers of those seats painted in yellow were considered slightly injured by the police. There were

only two unoccupied seats left in the bus, apart from the guide seat.

No occupant was wearing a seat belt. Even the driver, whose position was equipped with a three-point safety belt, was unbelted at the moment of the accident. The seat for the guide was also equipped with a three-point belt but this position was unoccupied.

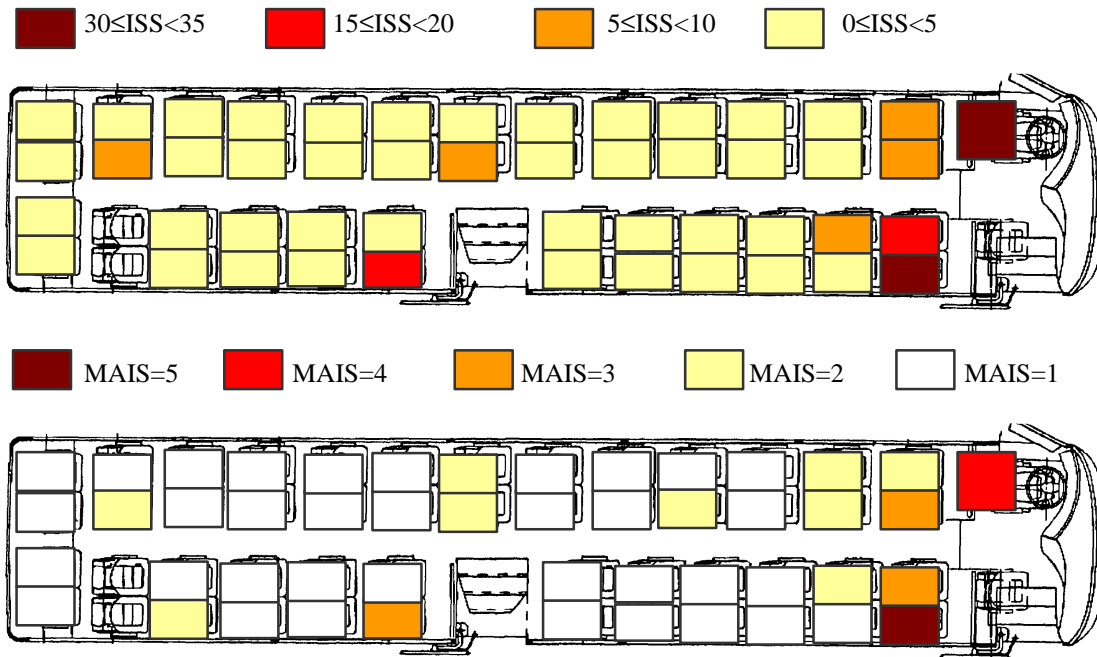
Figure 14. Severity of occupant injuries according to the classification scales.

The classification of injuries according to the Injury Severity Score (ISS) and the Maximum Abbreviated Injury Scale (MAIS) is represented in Figure 14.

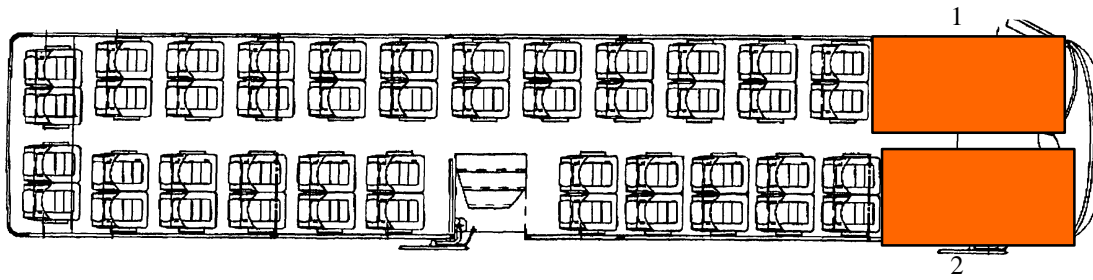
Figure 15. Areas selected for in-depth analysis.

The positions selected for an in-depth analysis are marked in Figure 15. They are corresponding to two representative situations. The area no. 1 comprises the driver and the passengers just behind him. The area no. 2 considers the passengers behind the guide seat.

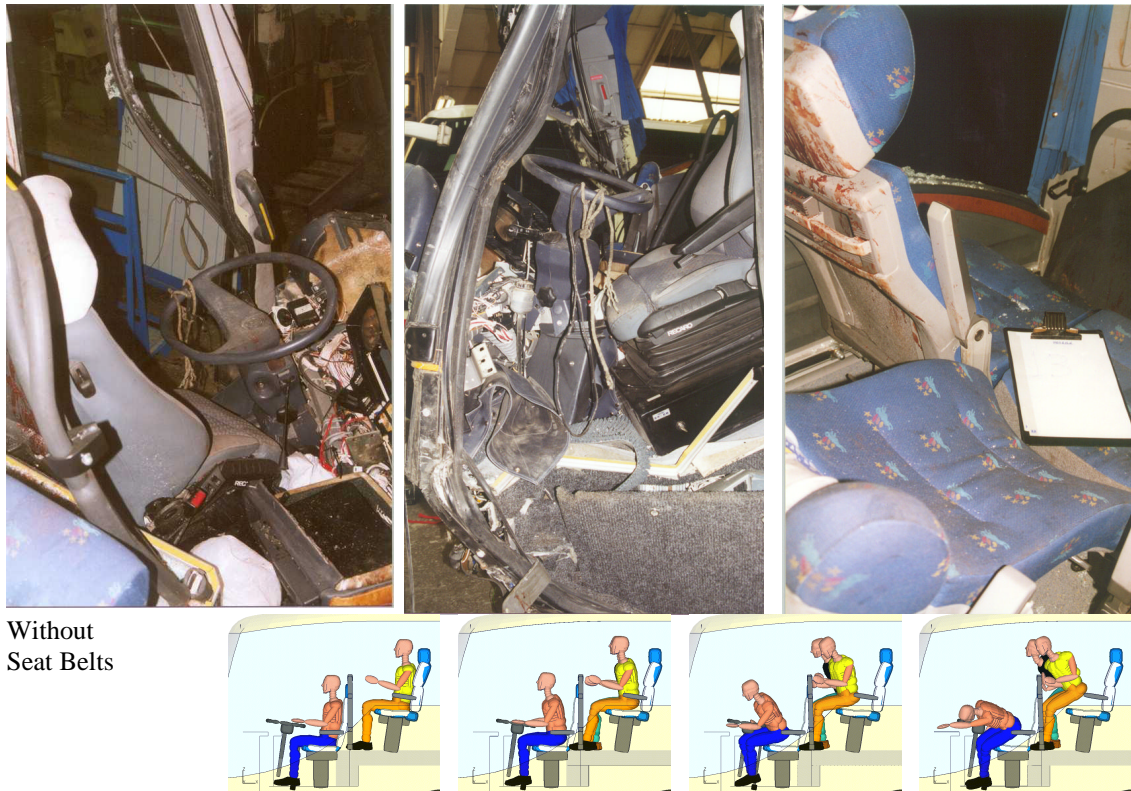
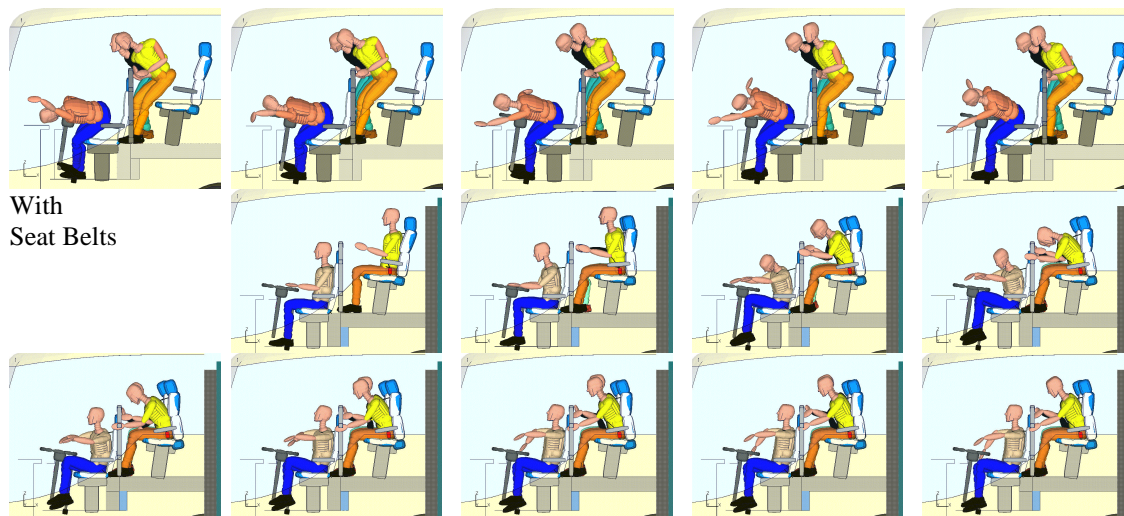
Figure 16. Photographs and MADYMO® animations for area no. 1.

each seating position. The properties of that seat belt were taken from an existing model of a bus seat. In the area no.1, the survival space for the driver is reduced due to the deformation of the frontal part of the vehicle. The driver's legs hit the frontal interior parts of the vehicle. A head impact against the side structure and a chest impact against the steering wheel occur only in case of not wearing the seat belt. The cause of his death was a head trauma that could have been avoided using the seat belt. Photographs and simulation results are shown in Figure 16.

The passengers behind the driver are ejected from their seating positions. The passenger on the left side is injured in the head due to an impact against the side structure of the vehicle and his legs hit the structure between him and the driver. The passenger on the right side suffers a serious injury in the upper part of the left femur, due to an impact against the structure in front of him. None of these injuries would be expected using a three-point seat belt.

Once again, ejection is occurring. A three-point seat belt was available for the driver but he was not wearing it. It could have saved his life.

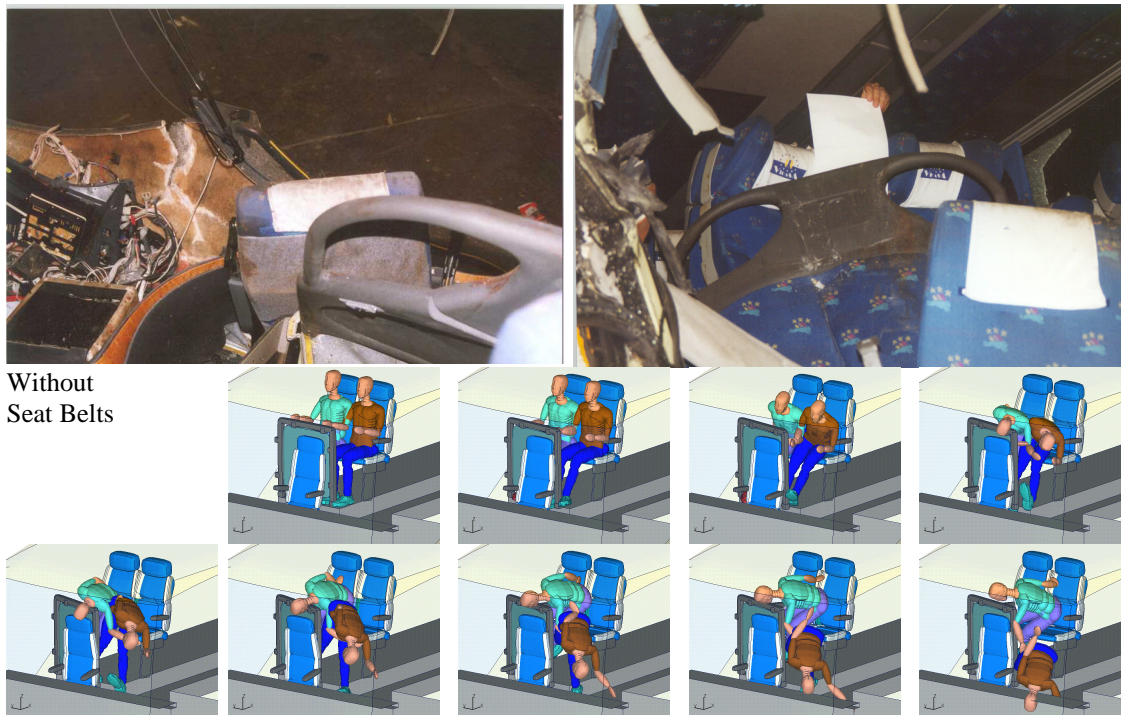
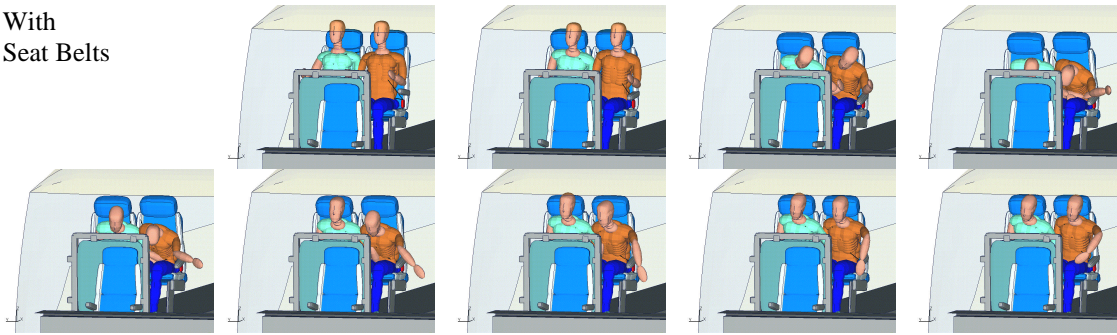
Figure 17. Photographs and MADYMO® animations for area no. 2.

In the area no. 2, the occupants move towards the corridor. Photographs and simulation results are shown in Figure 17. The total ejection of the left side passenger makes his head hit the floor. He died due to a head trauma and suffered multiple injuries in different parts of his body. The right side passenger died due to fatal injuries in the chest produced when hitting the structure between his position and the guide seat. None of these injuries would be expected using a three-point seat belt.

avoid injuries. A three-point seat belt would have reduced the risk of injuries in all of the seating positions, especially in those areas where the ejection of the passenger produced serious or fatal injuries.
